Lake Beulah Wave Impact Study

Final Report

Prepared for the Lake Beulah Management District

June 16, 2025

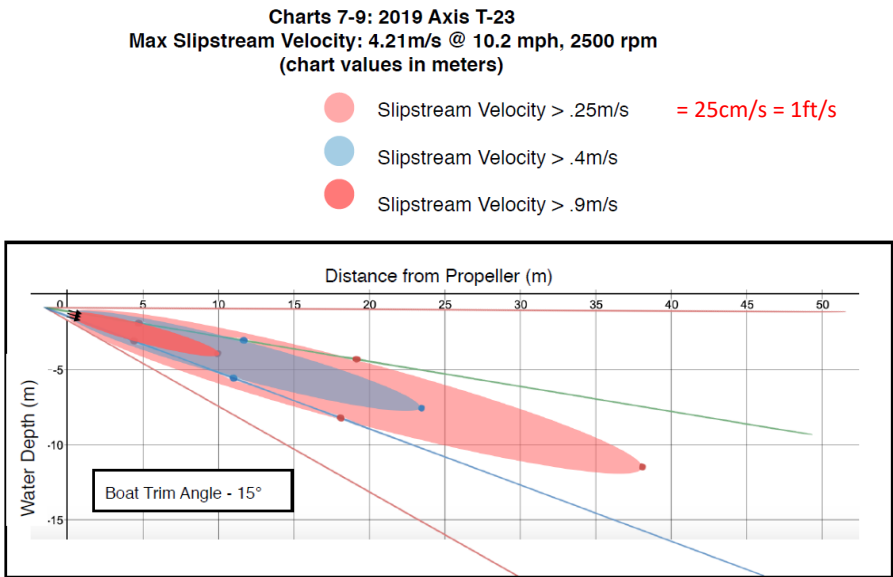
Figure 3 Slipstream Impacts Payette Lake. Ray (2021) Final Report, Payette Lake

Alex Ray from the Western Colorado University has completed a series of studies (2020-21) at Payette Lake, Idaho. This work has focused on the impact of propeller slipstreams (downwash) on lakebed sediments in Payette Lake. Based upon concern for nutrient load impacts to the waters of this large lake system, and specifically the risk of toxic blue green algae and other cyanobacterial blooms, the author studied non-buoyant jet streams produced by a current model, (2019 Axis T-23) wake boat in surf mode. Significant impacts from surf mode operations and their consequent slipstream lake bottom impacts on sediment redistribution were delineated in this work. See Figures 1 and 2.

*"According to modeling results, wake boat slipstreams have the potential to affect bed sediments at 33' of depth" Ray, 2021*

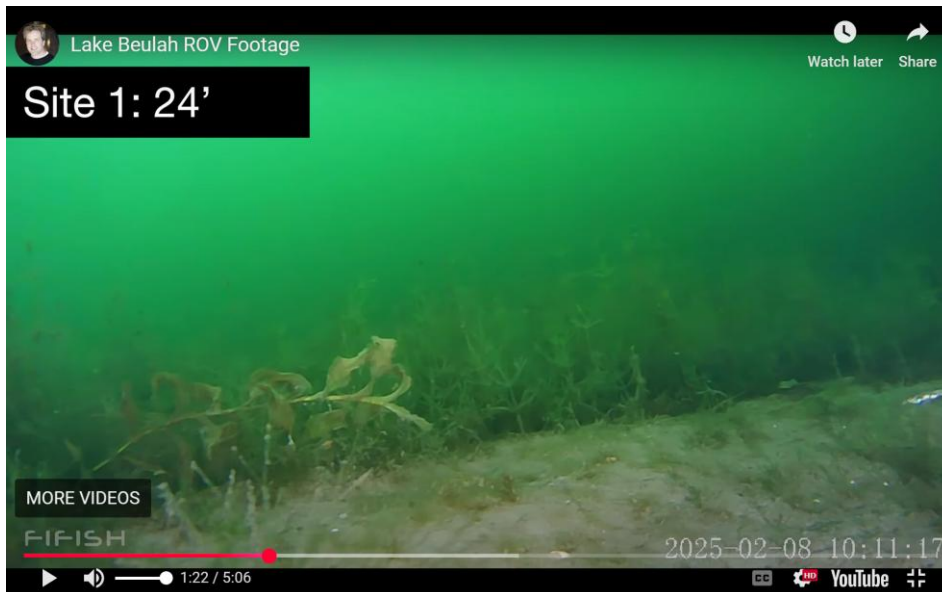
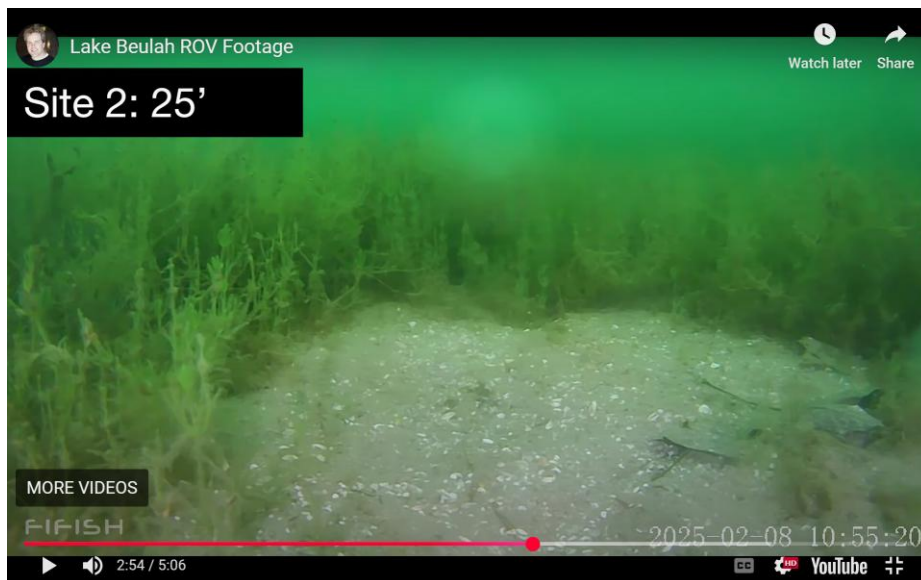
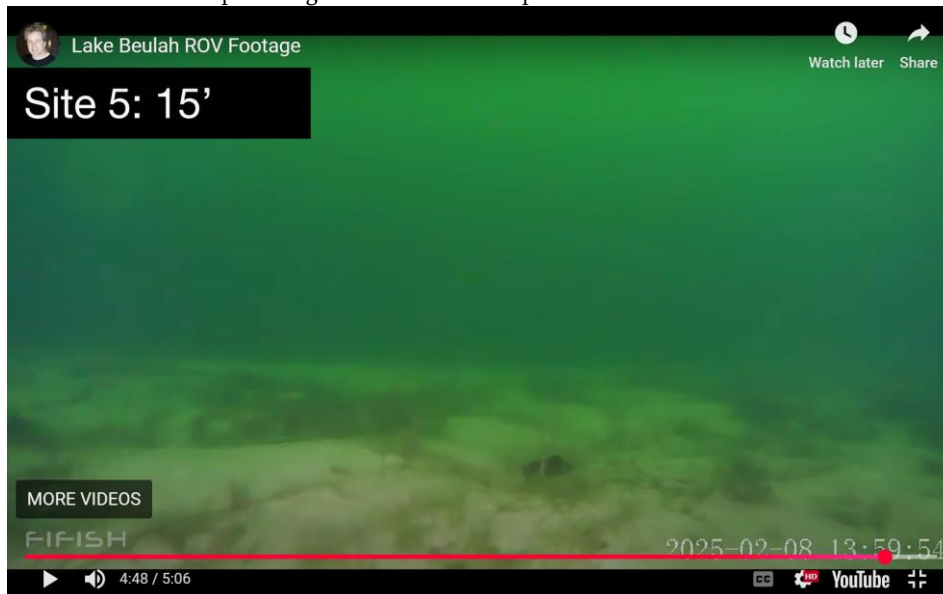
[Figure 11 Video Survey of Lake Bottom at Sites 1-5](#)

Site 1: West Horns 15-25 Foot Depth

Site 2: West Horns 15-25 Foot Depth

Site 3: East Horn 10-30 Foot Depth

Site 4: Mid-lake hump in Long Lake 15-30 Foot Depth

Site 5: Sandbar off Wilmers Point 15-30 Foot Depth

The Phase 1 Lake Beulah lake bottom survey results were gathered on 8 February 2025. A winter ice tent structure was erected at the pre-selected sites chosen by the LBMD authority. (See Figure 6) Multiple sites were used to gather lake bottom data imagery with a commercial submersible ROVER vehicle operated by a TVES professional commercial drone pilot using virtual FPV (First Person View) goggles and computer consoles as shown in the methodologies section. Clear evidence of substantial lake bottom disruption is revealed in these images. Of significance, the aquatic plant damage is extensive and notable for plant loss in large areas of the survey. Plant survey data provided to TVES by the LBMD establishes that these areas are heavily populated by several aquatic plant species including Cabbage (Broad-leaf Pondweed), Coontail and Chara. (See Figure 11)

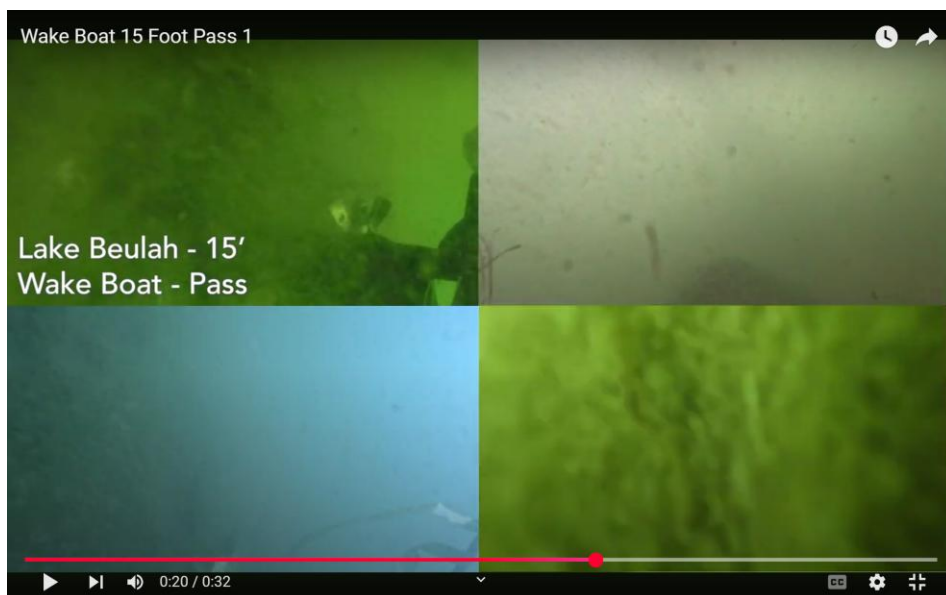
[Figure 13 Propeller Downwash Impacts of Wake Boat Pass at 15 Feet](#)

Phase 2 Propeller downwash test results reflect comparative data on subsurface impacts effected by a wake boat in surf mode and a planing water ski boat. Figures 12-15 reveal impacts to the lake bottom (sediment and plant disturbance) in both 15', 21' depths by wake boat in surf mode operations both for start-up and buoy pass (at operational speed) testing conditions. Minimal apparent impact is shown at 25' depth (a site with marl lake bottom and devoid of plant habitat). See Figures 16-17. Figures 18-19 do not reveal planing water ski boat impacts to the lake bottom at depths of 15 feet or greater.

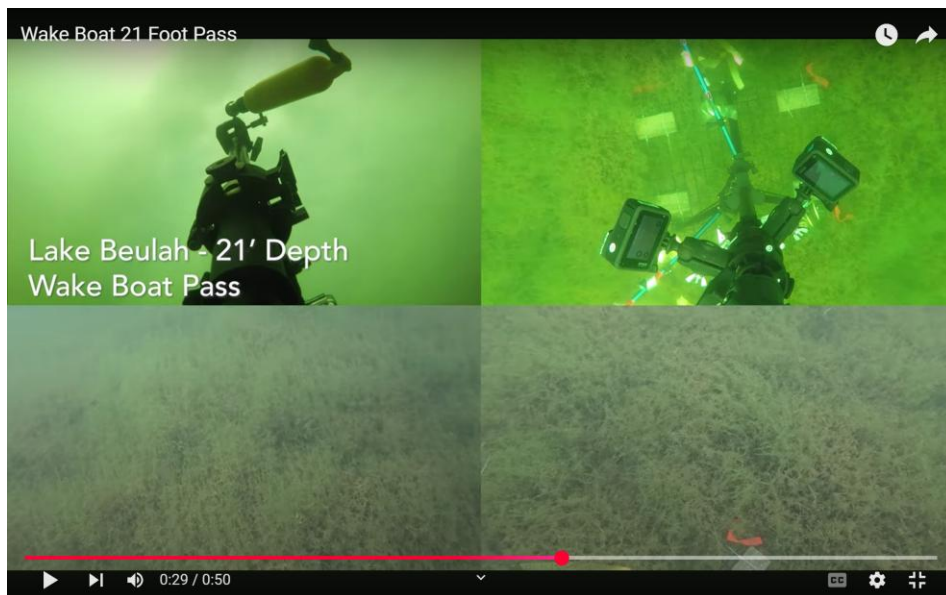
[Figure 15 Wake Boat Pass at 21 Feet](#)

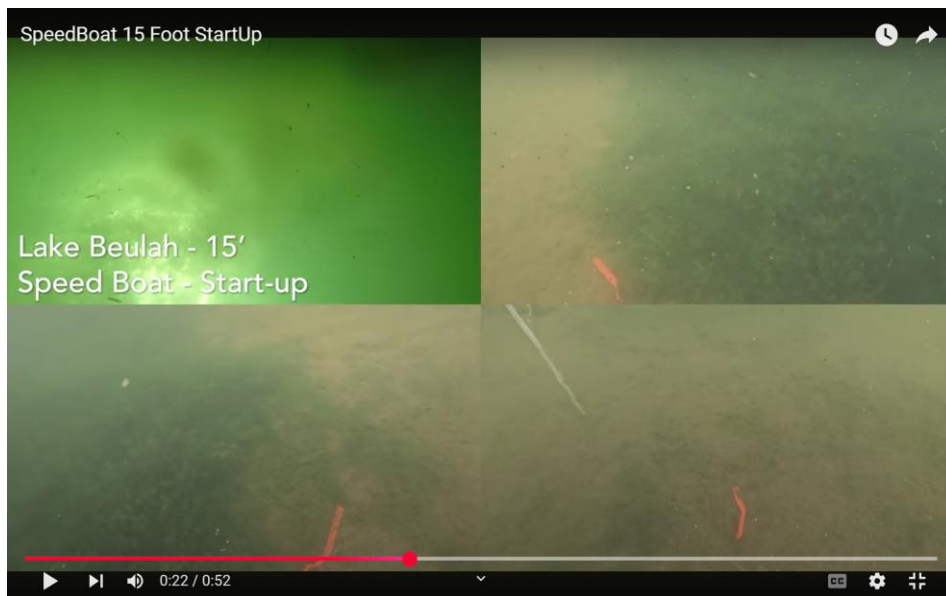
[Figure 18 Speed Boat Startup at 15 Feet](#)

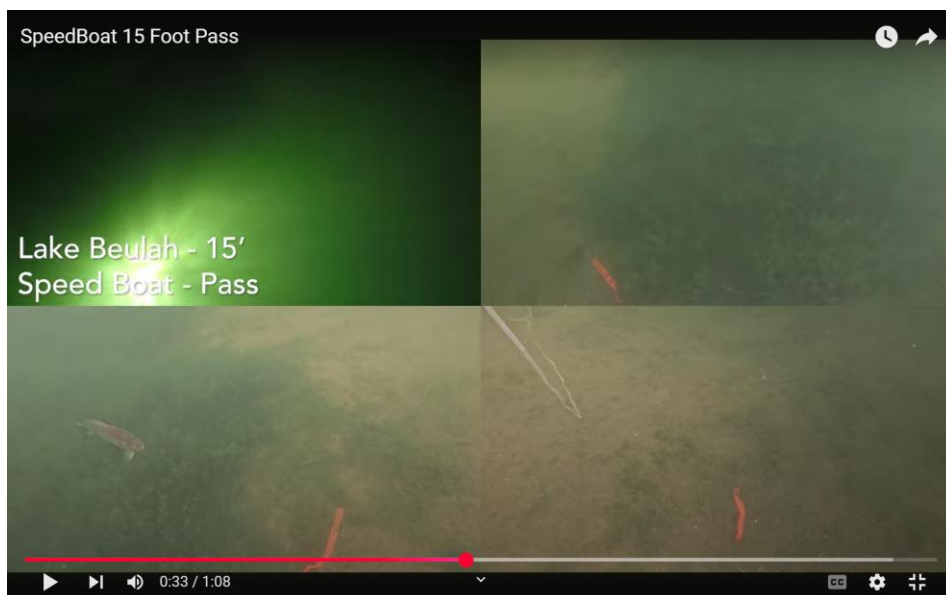
[Figure 19 Speed Boat Pass at 15 Feet](#)

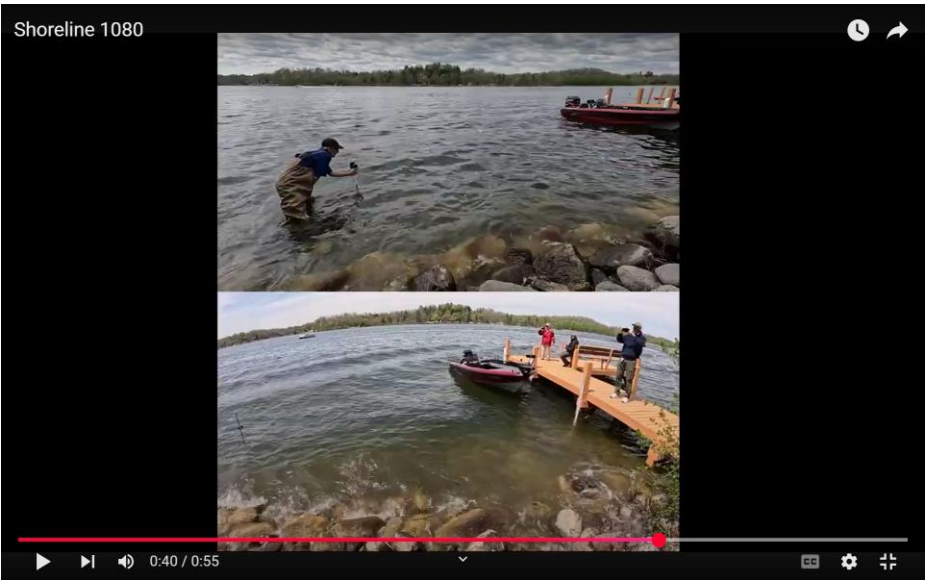
Figure 20 Video Comparison of Waves Generated 200 Feet from Shoreline of Wake Boat in Surf Mode vs. Planing Ski Boat

Wave propagation from series of near shore passes at operational speeds at 200 feet from the shoreline for both wake boat in surf mode and planing water ski boats were recorded for demonstration of wave characteristics including wave heights, wave trough depth, and wave amplitude features and near shore surface impacts. (See Figure 20) Wave height and the resulting wave energy impacts to dockage and a tethered vessel at the dock, are clearly different upon review of the wake boat in surf mode verse planing water ski boat operations. (See Figure 21) Wake boat in surf mode wave effects are more impactful to both dockage, tethered vessels and the shoreline structures compared to a planing water ski boat.

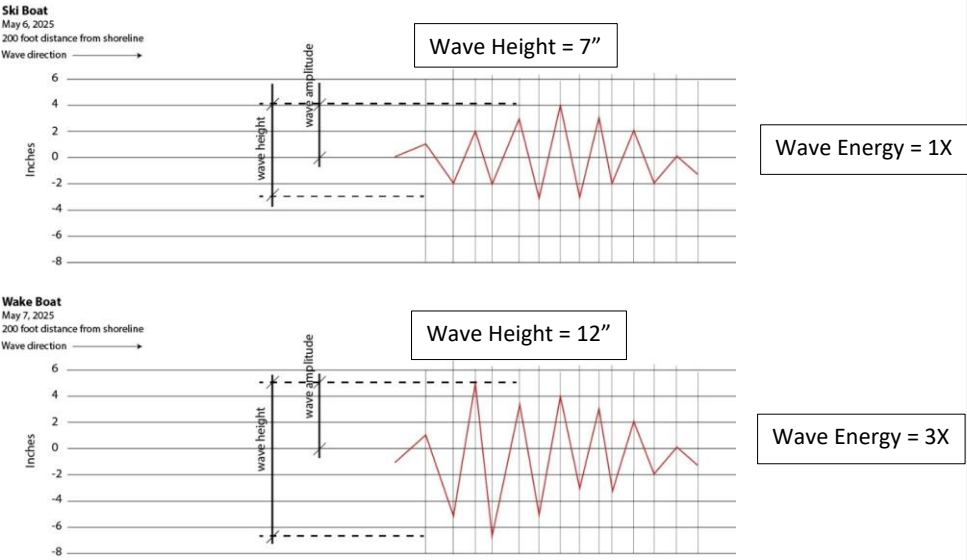
Figure 21 Wave Height and Energy Comparison from Pass 200 Feet from Shoreline

Wake Surf wave height is 1.7-2X as high as a planing boat at the same 200-foot distance from shore. This results in Wave Energy from a Wake Boat in Surf Mode that is 3-4X the amount of Wave Energy from a planing ski boat at the same 200-foot distance from shore. To dissipate the Wake Boat in Surf Mode wave to the same height and energy as a planing Ski Boat at 100 ft (State statue) requires increasing the distance from shore to over 500 feet. This corresponds with results from other studies including: Marr, WEC, NLMD.
